Aquatic Plant Management Plan
White Ash and North White Ash Lakes
White Ash Lake Protection and Rehabilitation District

**AQUATIC PLANT MANAGEMENT PLAN
WHITE ASH AND NORTH WHITE ASH LAKES**

JANUARY 2023

Flambeau Engineering, LLC
PO Box 273
Park Falls, WI 54552

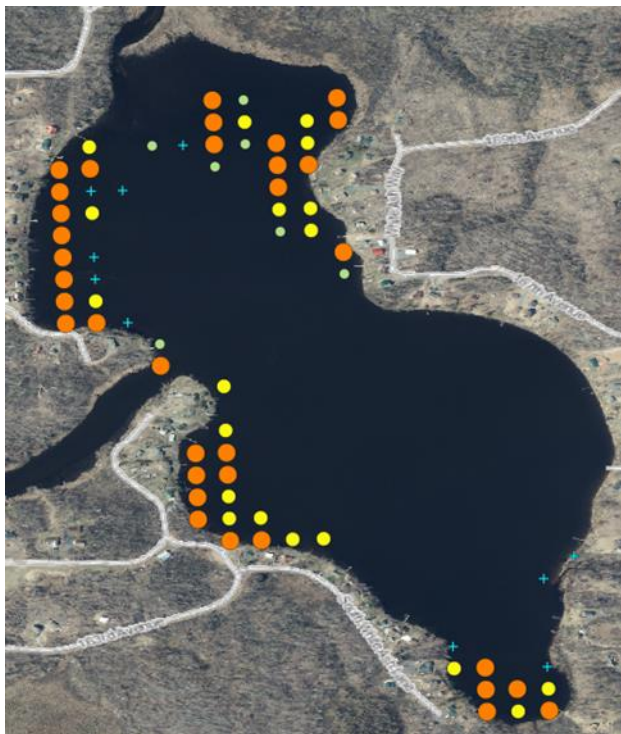
Figure 7 White Ash - CLP Bed Locations

Symbols: blue – visual, green - low density, yellow – medium density, orange – high density

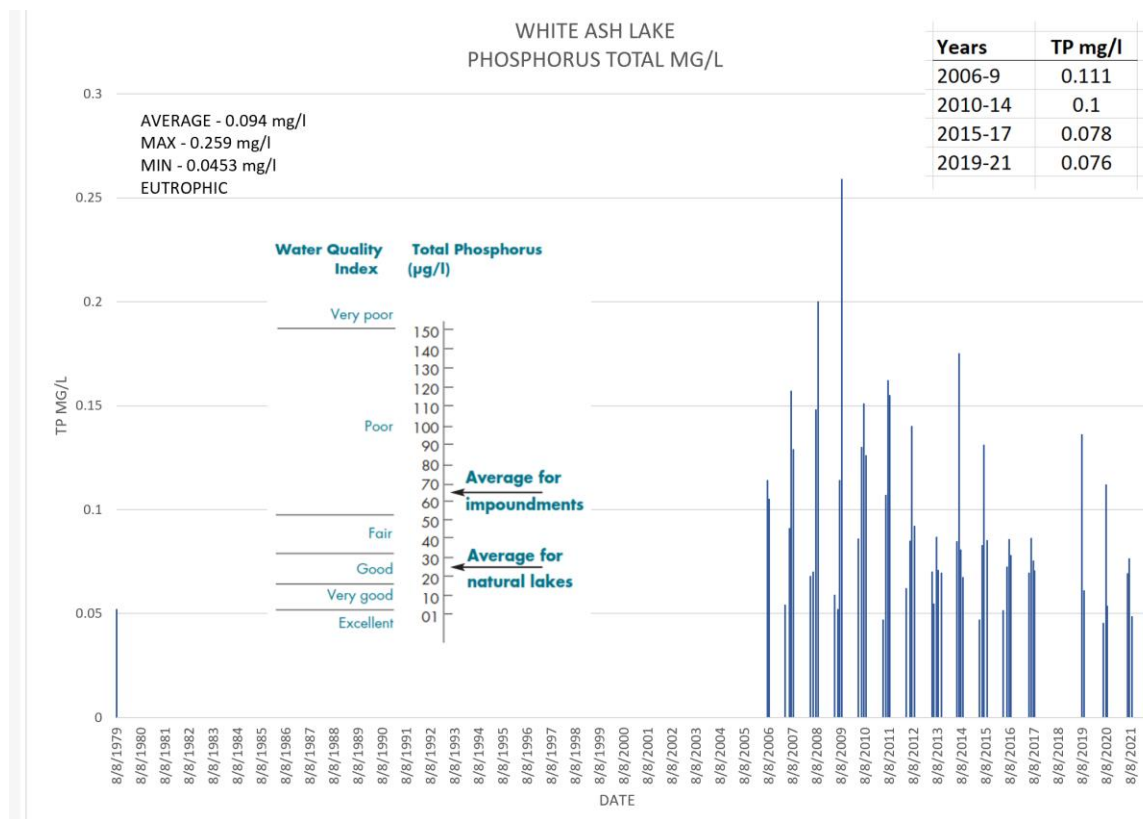
Figure 13 - White Ash – Total Phosphorous

The graph indicates the TP has been decreasing since a peak in 2009.

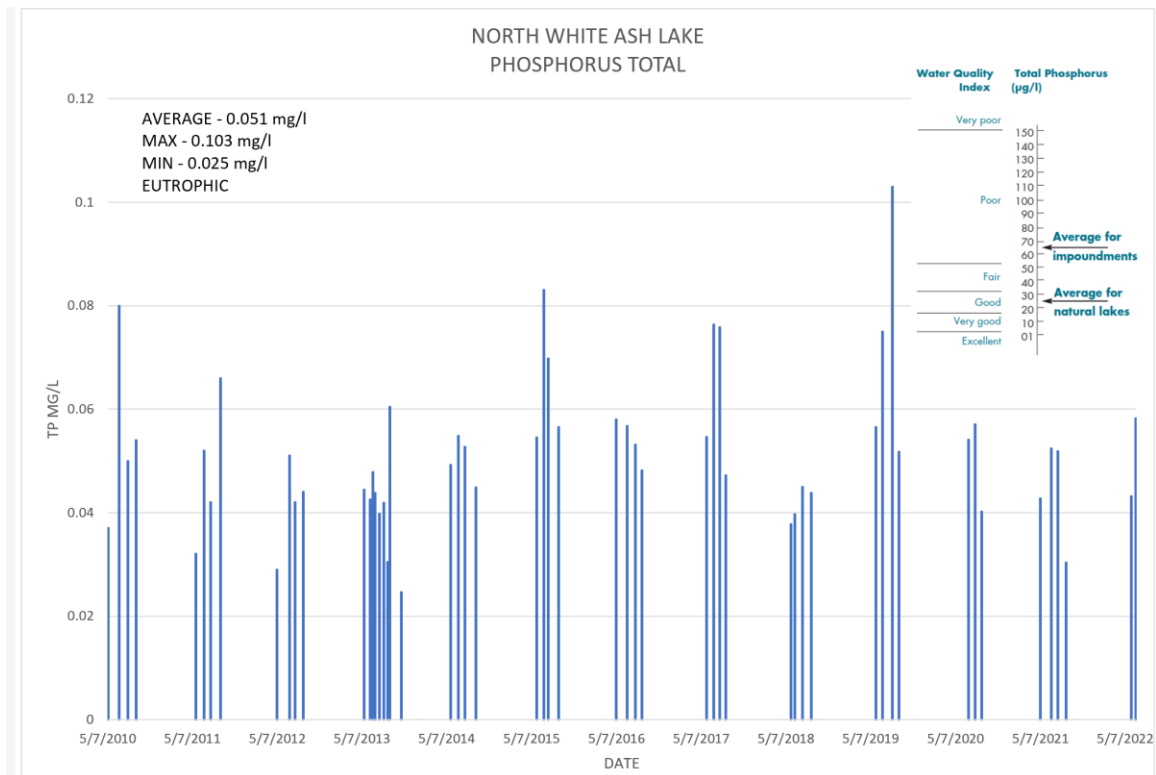
Figure 14 - North White Ash – Total Phosphorous

The TP in North White Ash has remained relatively steady but is showing a downward trend since an average high in 2015. One item to note is the spike in 2019; the highest recorded TP levels occurred following the tornado in 2019. This is likely due to the increased runoff during the storm and the mixing of the lake that occurred from the turbulence created by the tornado passing over.

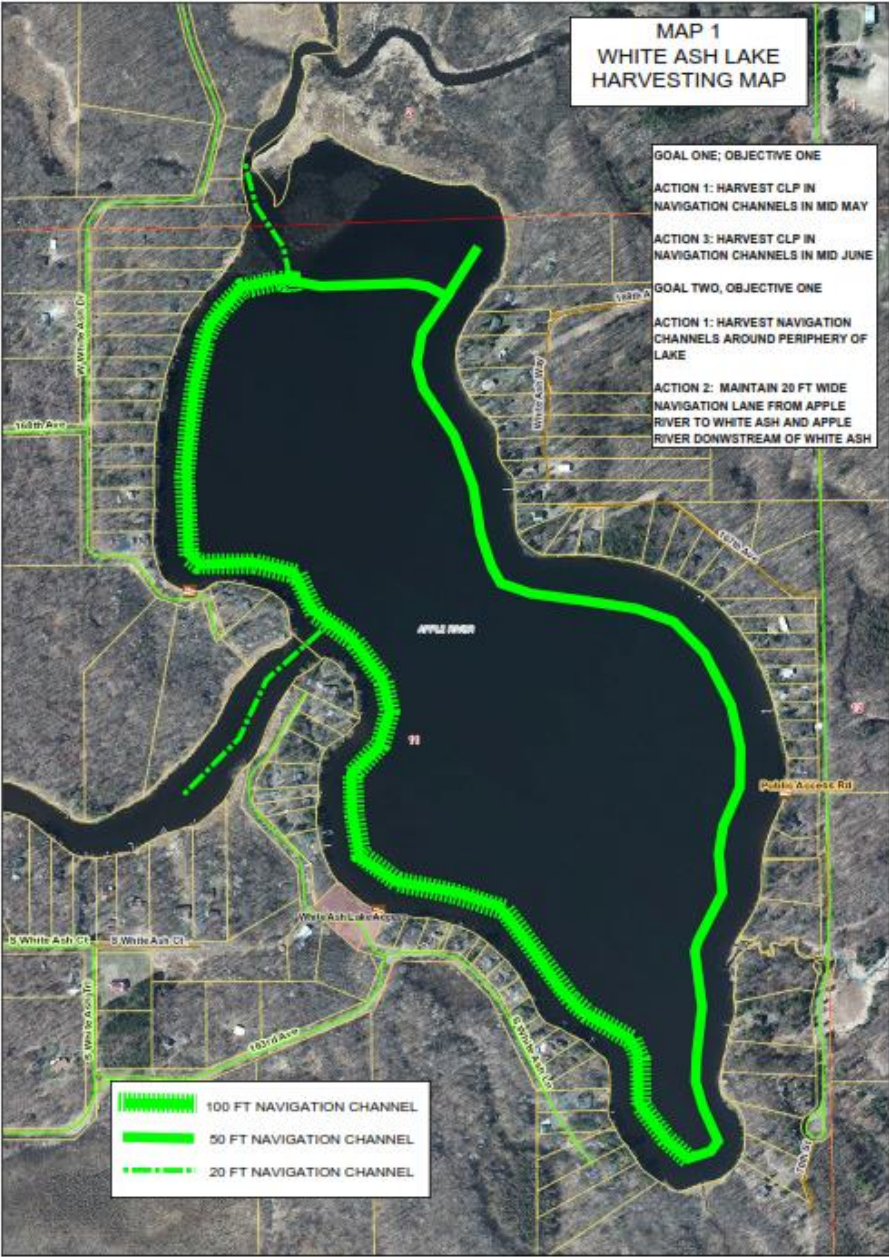
MAP 1 – WHITE ASH LAKE HARVESTING MAP

The 1998 Plan (Barr Engineering, 1998) recommended a large-scale harvesting plan for both lakes. Harvesting activity on the South Lake was originally designed to provide 20-ft wide navigation channels for lake-users living adjacent to very dense areas of plant growth. Total native vegetation removed was around 5.3 acres. Harvesting on the North Lake was to provide a 20-ft wide navigation channel around the lake and additional channels throughout the lake to facilitate fishing and boating, and to provide a swimming area for interested lake users. The total acreage to be harvested on the North Lake was around 8.7 acres.
